ADMINISTRATIVE RECORD FILE INDEX

SITE NAME: (Odessa Drum Company

SITE NUMBER: TXD008012254

INDEX DATE: April 11, 1991

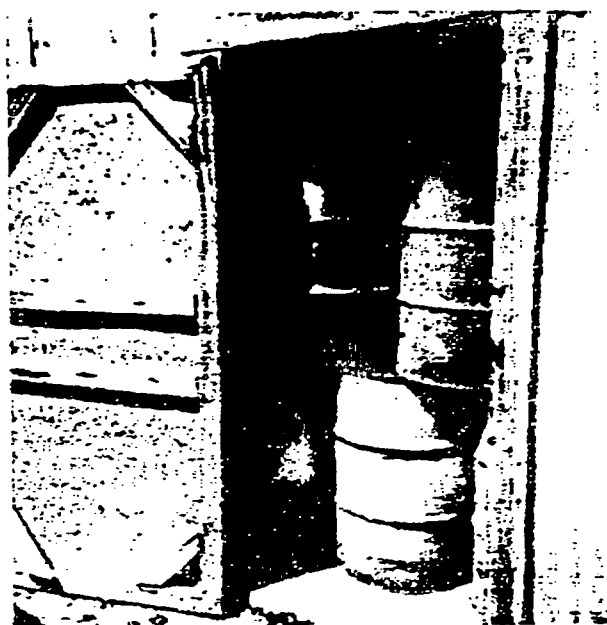
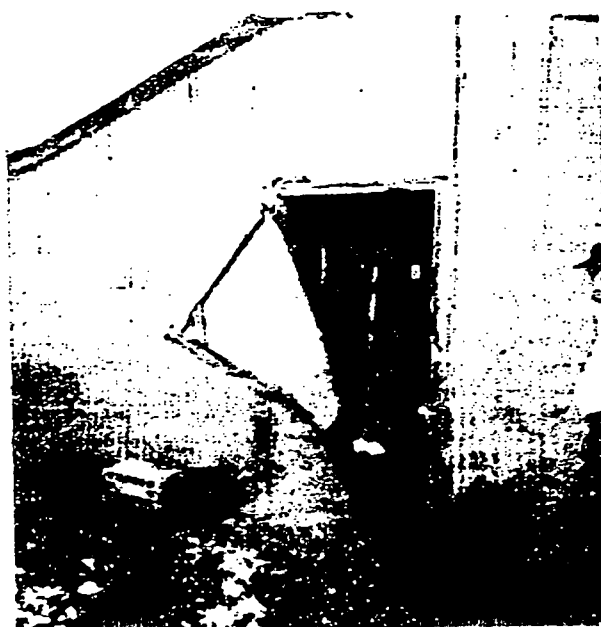
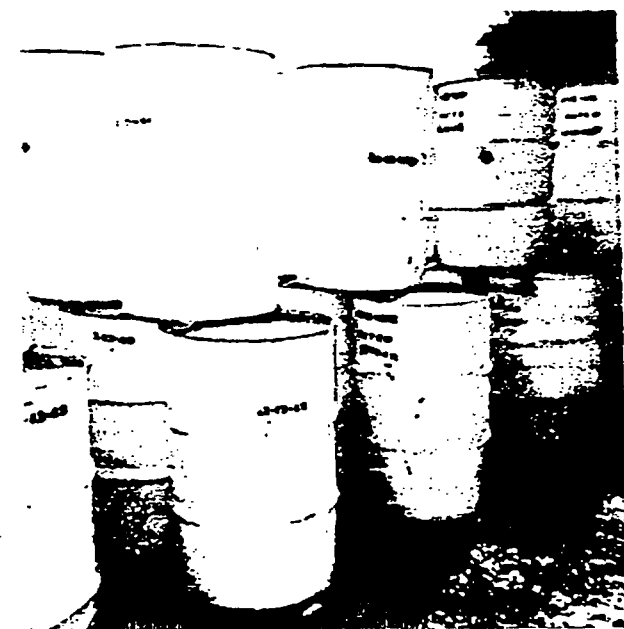
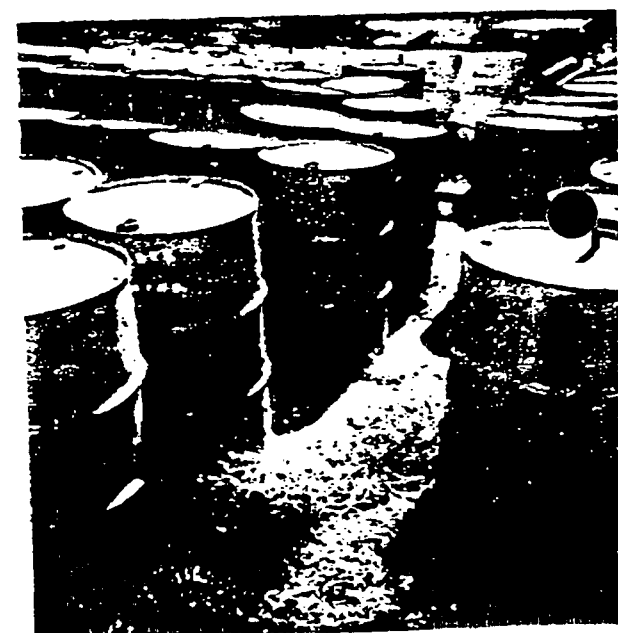
60. Photo shows a drum leaking an unknown waste material near the drum described in Photo #59.
61. Facing West - Photo shows a white open top drum located on the east side of the drum reconditioning area near the above ground diesel fuel tank. The drum was approximately 2/3 full of an unknown waste material.
62. Photo shows the contents of the drum described in Photo #61.
